Avoid unsafe work practices around conveyors

From Canadian Biomass March 29, 2021

By Martin Engineering

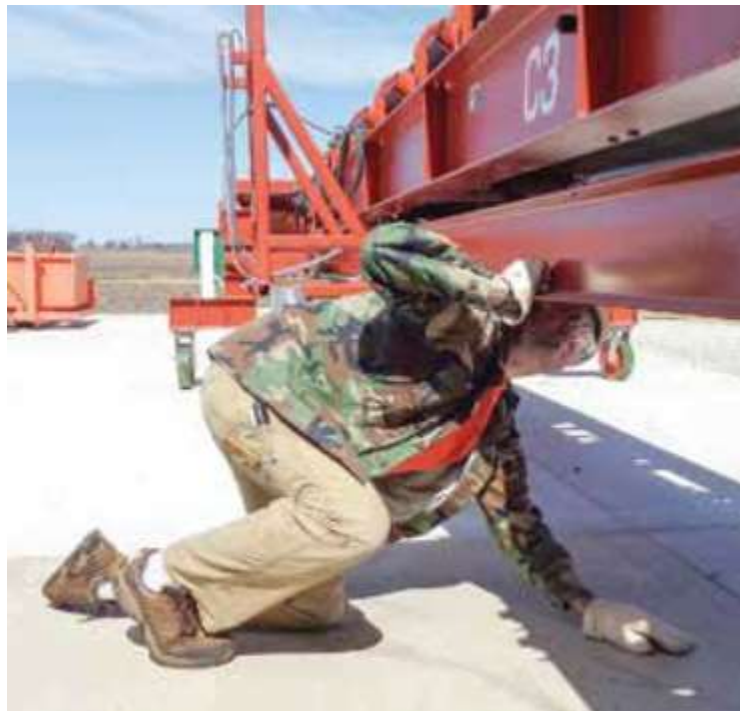
Taking a shortcut by crossing over or under a conveyor can lead to injury. Martin Engineering photo

Other potential unsafe behaviours include crossing a conveyor in a risky manner. Conveyor belts are often lengthy systems bisecting a production facility. Workers may be required to cross a conveyor line to get to an area that is in need of service or maintenance. To save time, a worker is likely to step over or cross under a conveyor.

Crossing under offers multiple hazards. If any of the worker's body parts come in contact with the moving conveyor, it will either act like a grinder and abrade the skin or pull the worker toward rolling components. Crossing under also places the worker at risk from falling objects.

Crossing over a conveyor without using a designed and designated crossover structure offers dangers, as well. There is a high potential for a slip and fall. If lucky, the worker may fall on the ground; if not, the worker will fall onto the conveyor belt. If the conveyor is in operation, the worker may be carried downstream. This can result in contact with the conveyor structure and rolling components or being thrown off the conveyor at the discharge. The safe approach to crossing a conveyor is to use a designated crossover or cross-under point engineered for that purpose.
